WAKEFIELD SHOPPING CENTER
1309-21 Court House Road
Arlington
Virginia

HABS VA-1279
VA-1279

WAKEFIELD SHOPPING CENTER

HABS No. VA-1279

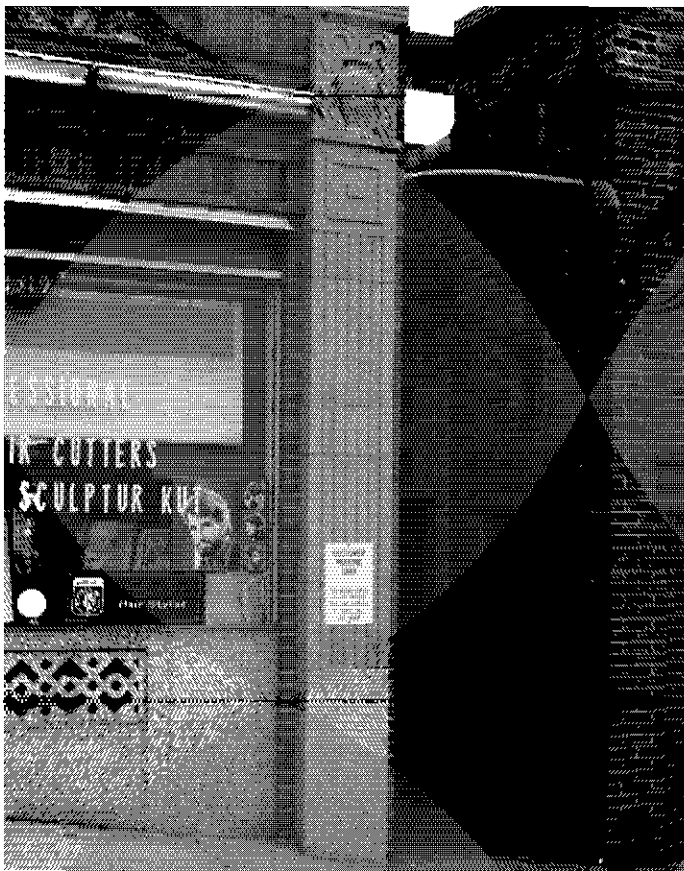
Figure 1. View of the shopping center showing the central tower, alley, and pilaster detail at Nos. 1317 and 1319 North Court House Road. The photograph was taken by John C. Schwartz in April 1990.
